Mayor's Fire Facility Task Force

A Strategic Plan for the Danbury Fire Department

30 November 2010

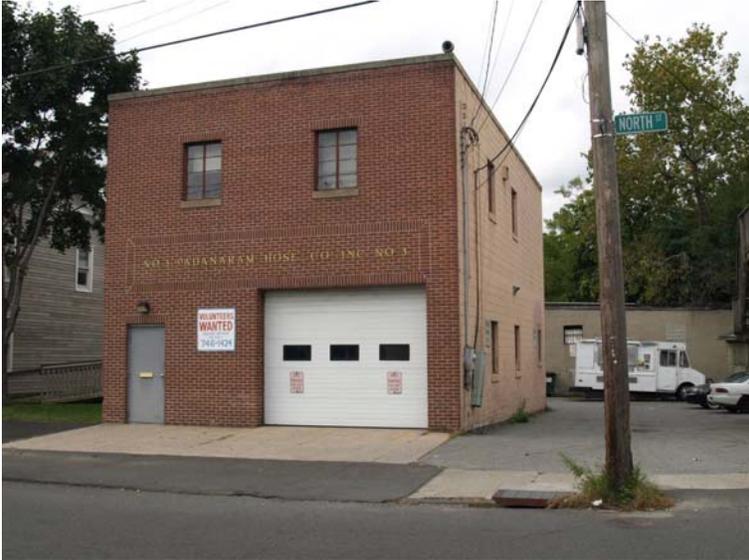
Padanaram Hose Co. #3 – North Street

The three volunteer stations housing companies Padanaram 3, Wooster 5 and Citizens 6 are of more serious concern. Padanaram 3 is situated on the busy thoroughfare of North Street. Traffic concerns make access difficult and extremely hazardous. The structure, built in 1950, is in need of repairs to its roof, fire escape, windows and façade. The house is small for a modern single engine house and storage capacity for equipment is lacking. Office and assembly space is minimal. Parking for responders and others is critically limited. The bay area should be much larger and higher in order to properly perform maintenance and service checks.

- **Build a consolidated volunteer station on the south side. (i.e. South St. area):**
 - **JUSTIFICATION:** House the three volunteer companies with the most concerning structural and location issues. We recommend the city sell the three current volunteer properties. The proposed companies comprise Padanaram #3, Wooster #5 and Citizens #6.

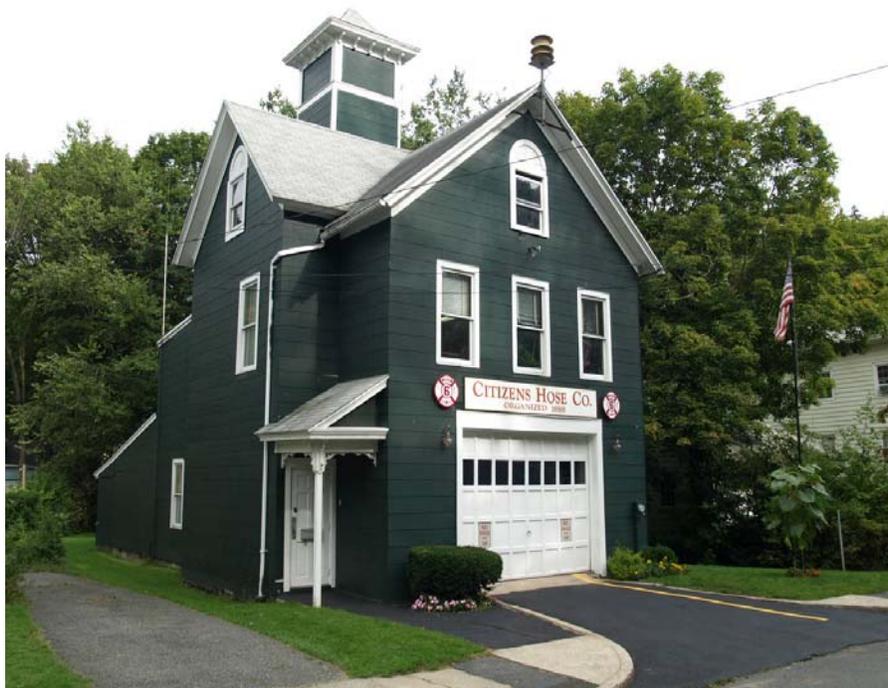
Citizens Hose Co. #6 – Jefferson Avenue

Citizens 6 has many issues similar to Wooster 5. Both stations need significant upgrades in HVAC systems, windows, siding and kitchen facilities. No volunteer station has a station generator in the event of power failure.

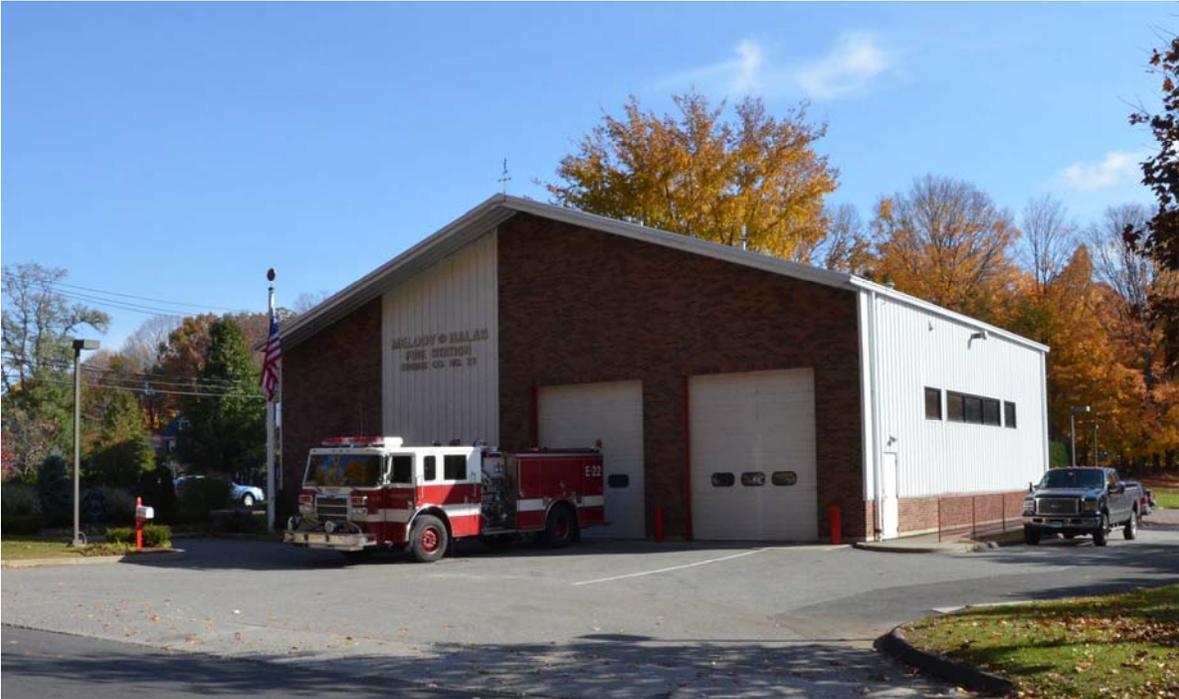
Engine 23 – Osborne Street

Several concerns that have developed during the last several years include leaks in the roof, gutter failures and most recently, a significant problem with the generator for the structure. These have been addressed.

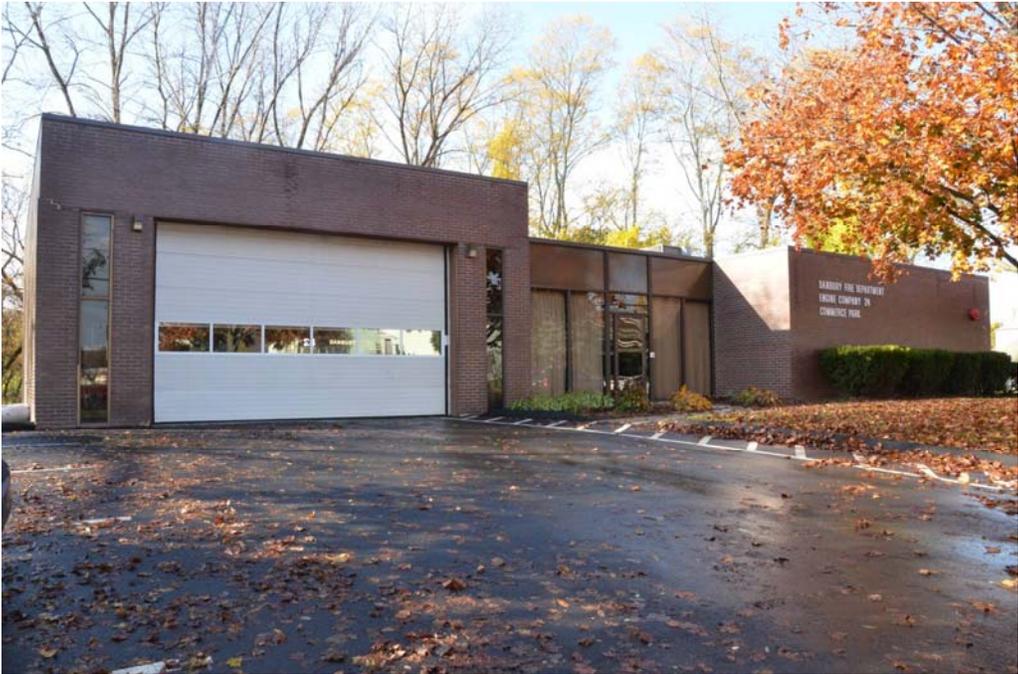
Engine 24 – Eagle Road

Engine 24, on Eagle Road is a structure built and donated in the early 1970's. The response area is primarily commercial and manufacturing with residential making up the remainder. This structure, now nearing 40 years old, has minor structural concerns including a brick façade separated from block wall, windows in need of repair and knee walls that should be added according to a report from a consulting engineer in 2008. Many additional repairs and modifications were recommended. An additional need is a fully integrated generator to power the facility in the event of loss of outside electrical supply.

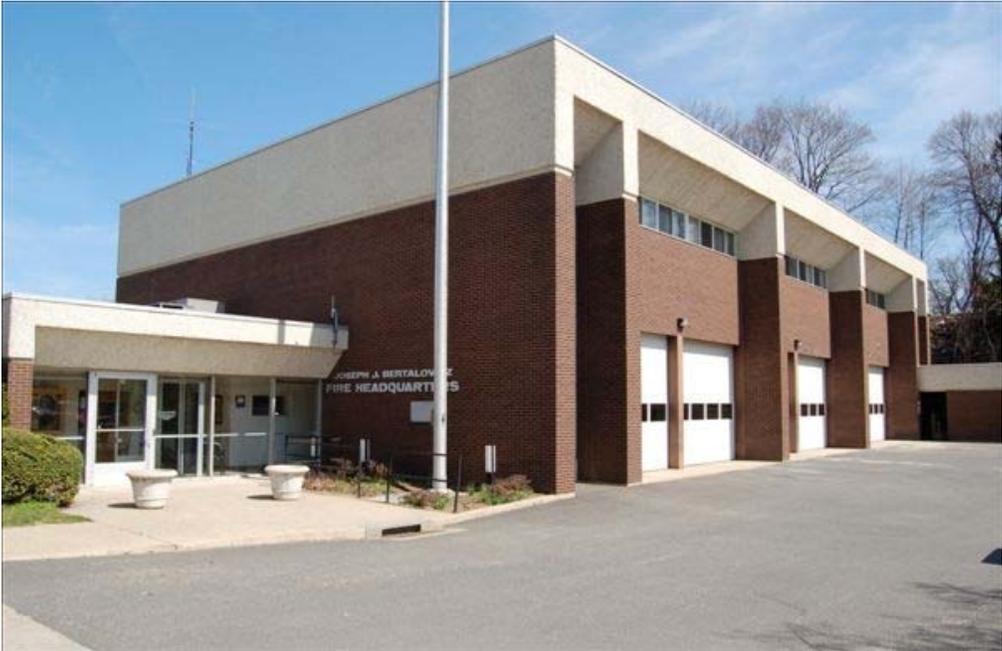
Headquarters – New Street

- **JUSTIFICATION:** This station was designed and constructed in the late 1960's. It has served with increasingly crowded and antiquated facilities since that time. As explained in other areas of this report, the building is literally bursting with locker rooms converted to classrooms and offices, closets removed to enlarge offices and every possible space in use. The grounds have inadequate parking spaces and the storage of trailers and emergency vehicles outside the building has reached more than full capacity with parking on grass areas. The site might allow for increasing the structural size and therefore the task force recommends the city conduct a full engineering study to determine the potential for either rebuilding on the current location or finding a new larger site to fully meet the demands.

○ **Replace or remodel to necessary specifications Headquarters at 19**
